January 12, 2001

Captain Mohsen El Missiry  
Chief of Egyptian Investigation Committee

Response of EgyptAir  
to  
October 31, 2000 Submission of  
The Boeing Company  
Regarding  
The EgyptAir Flight 990 Investigation

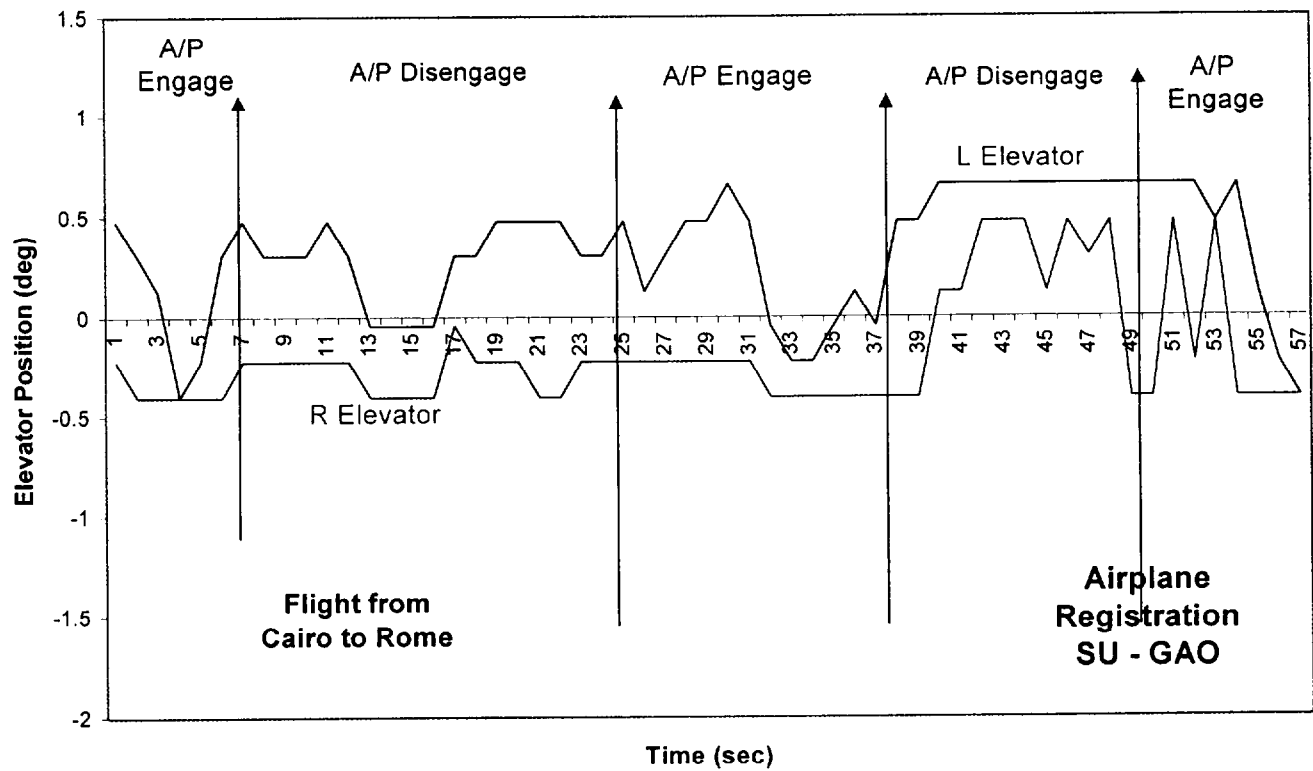
Figure 1. Elevator Response to Autopilot Disconnect on an Airworthy B-767

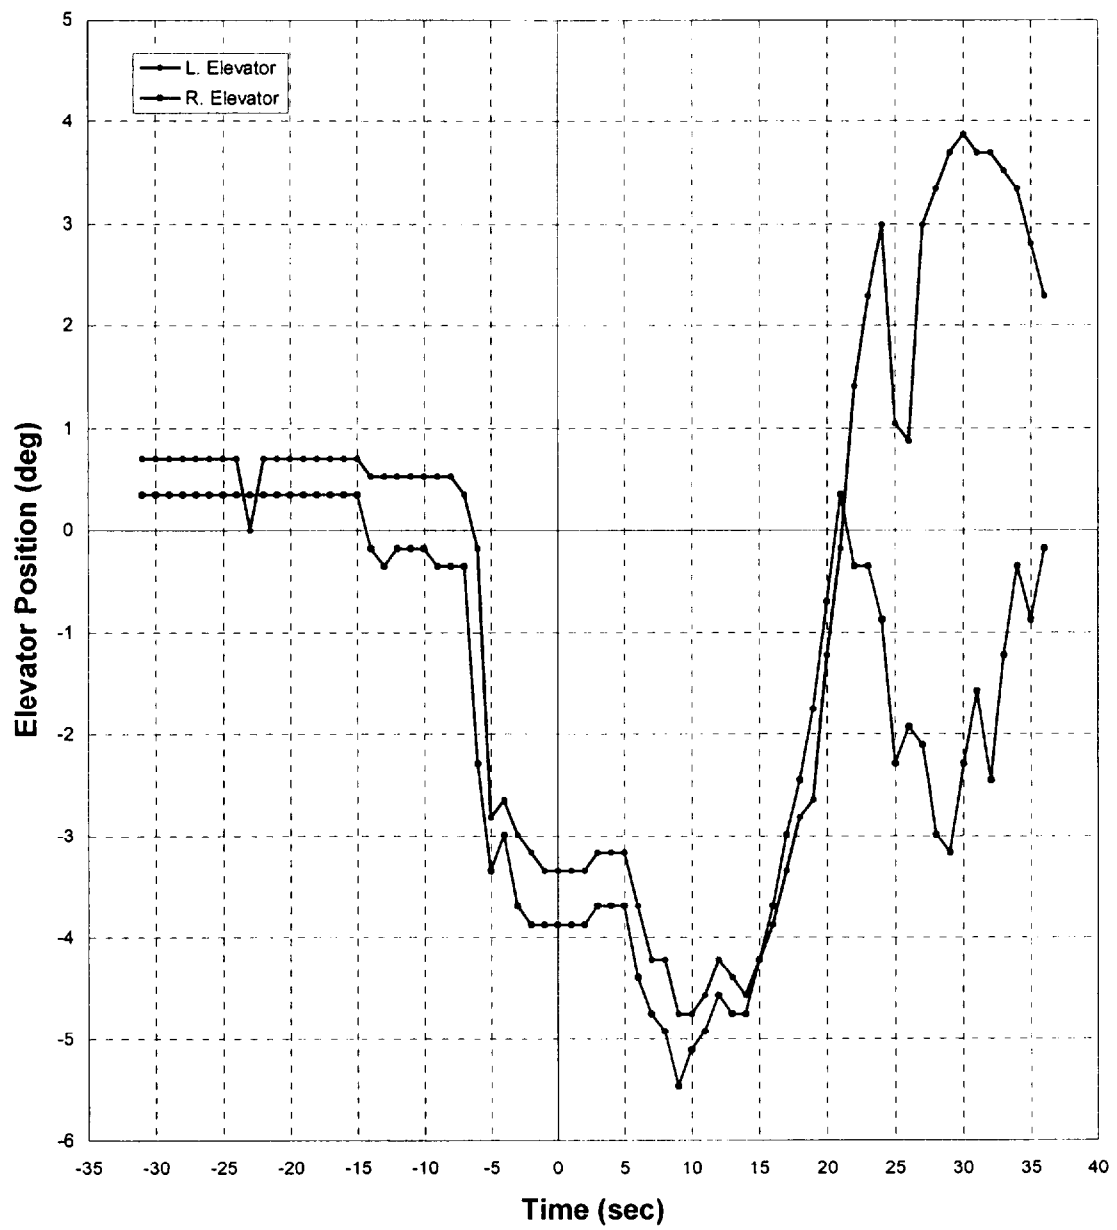
Figure 2. FDR Elevator Deflection

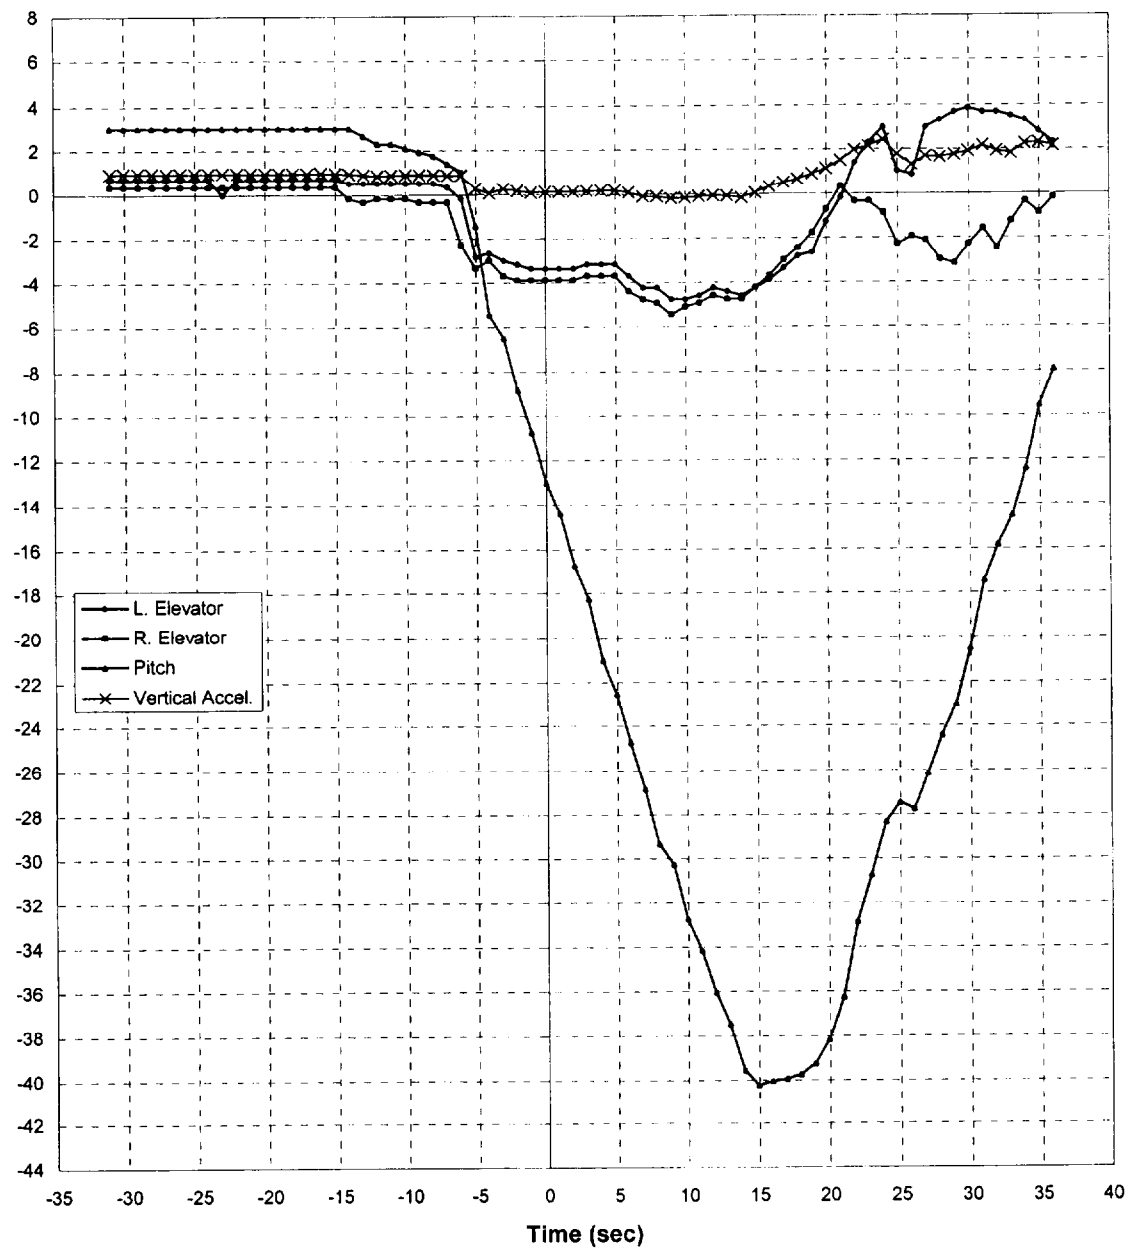
Figure 3. FDR Elevator Deflection, Pitch, and Vertical Acceleration

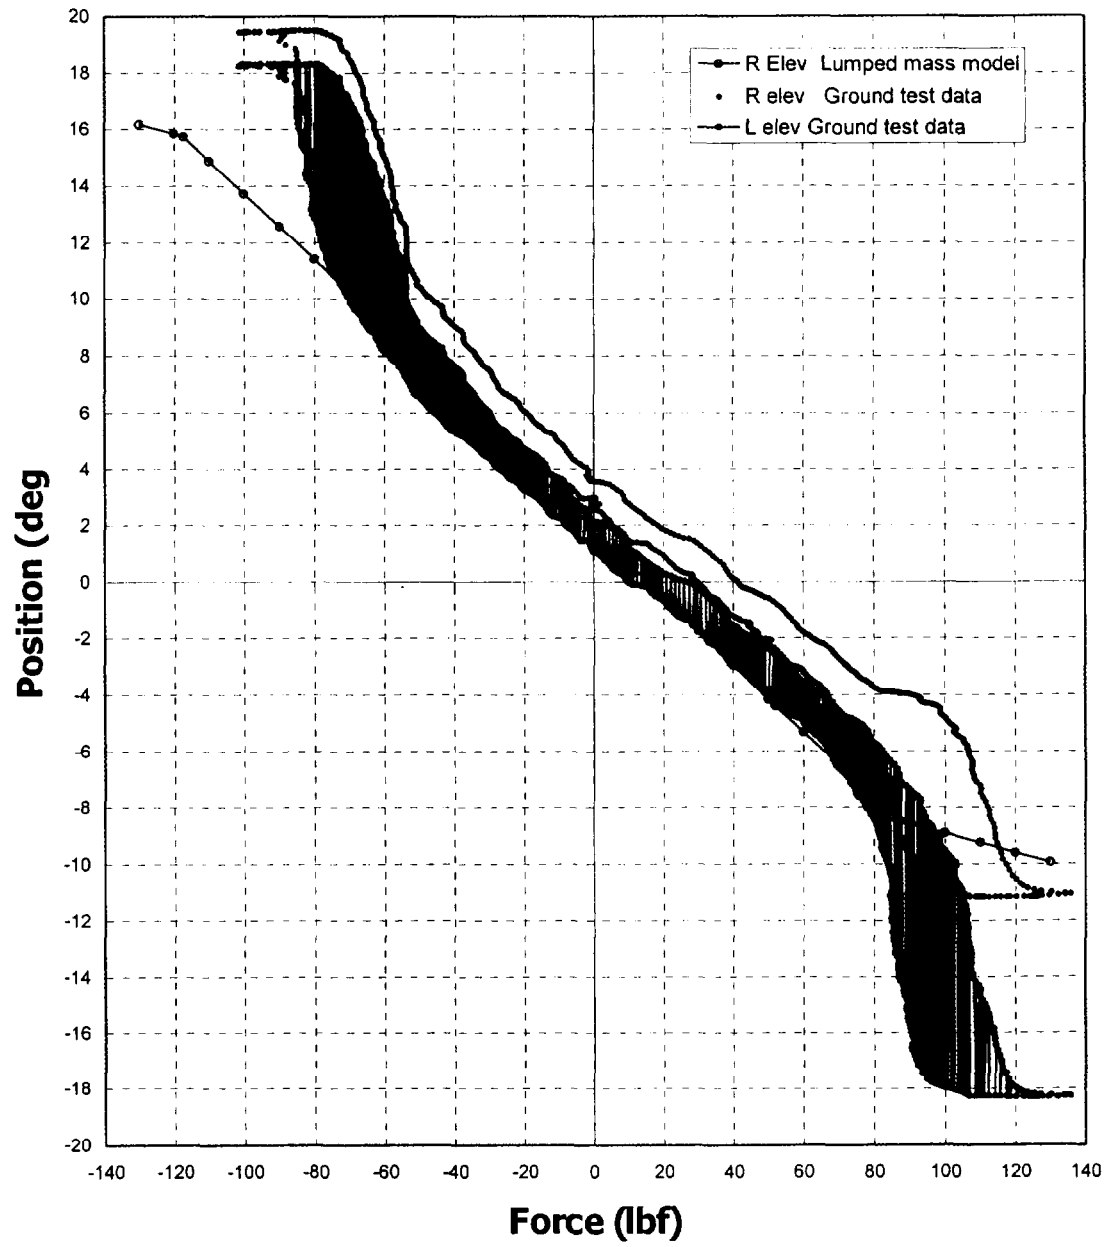
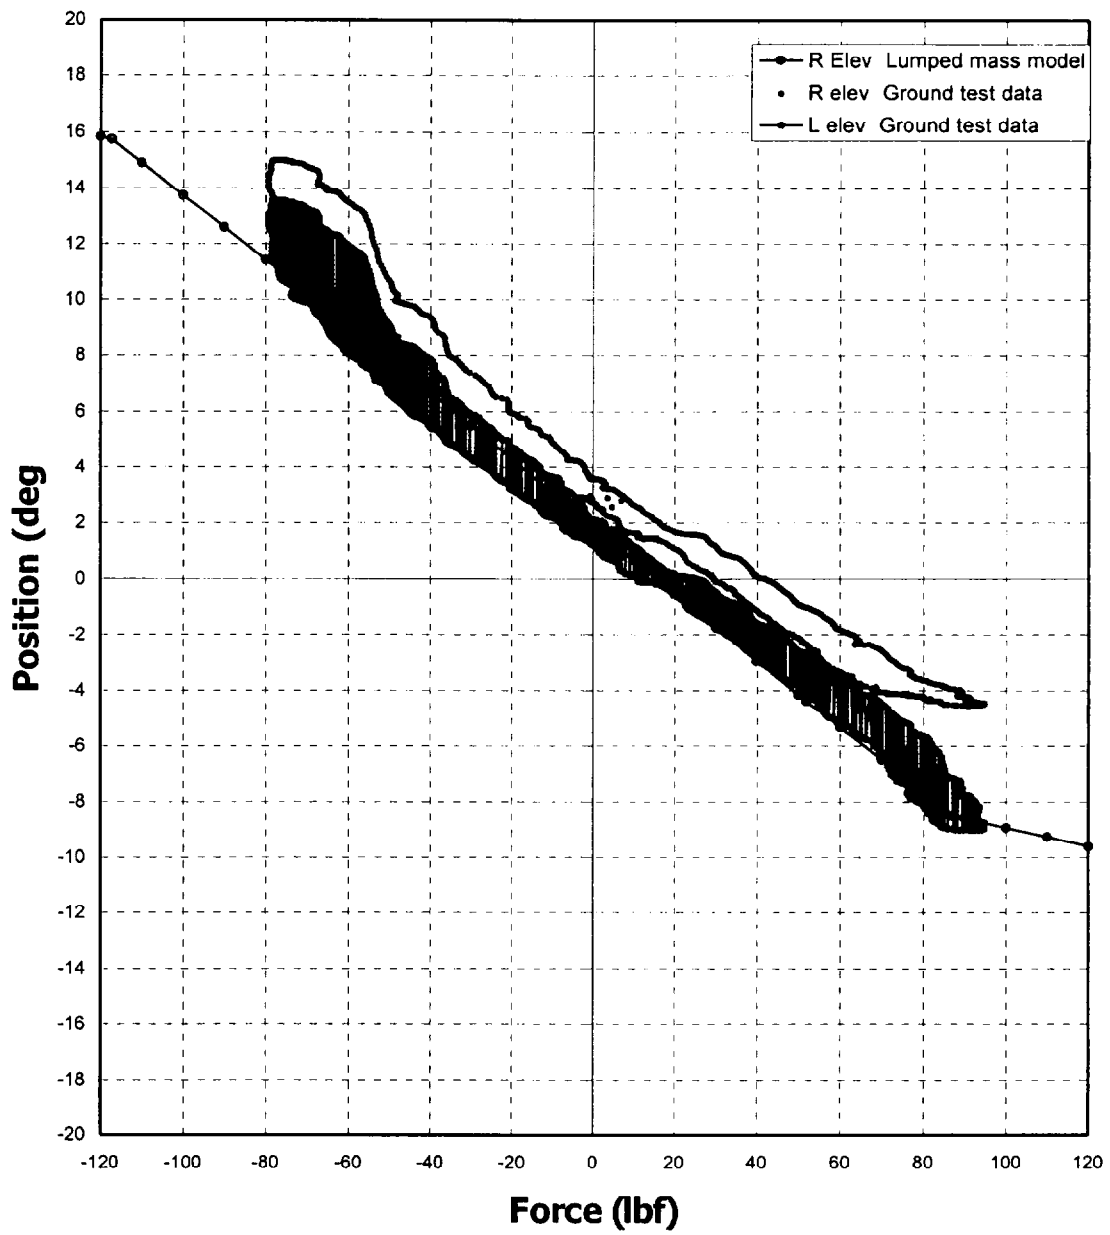
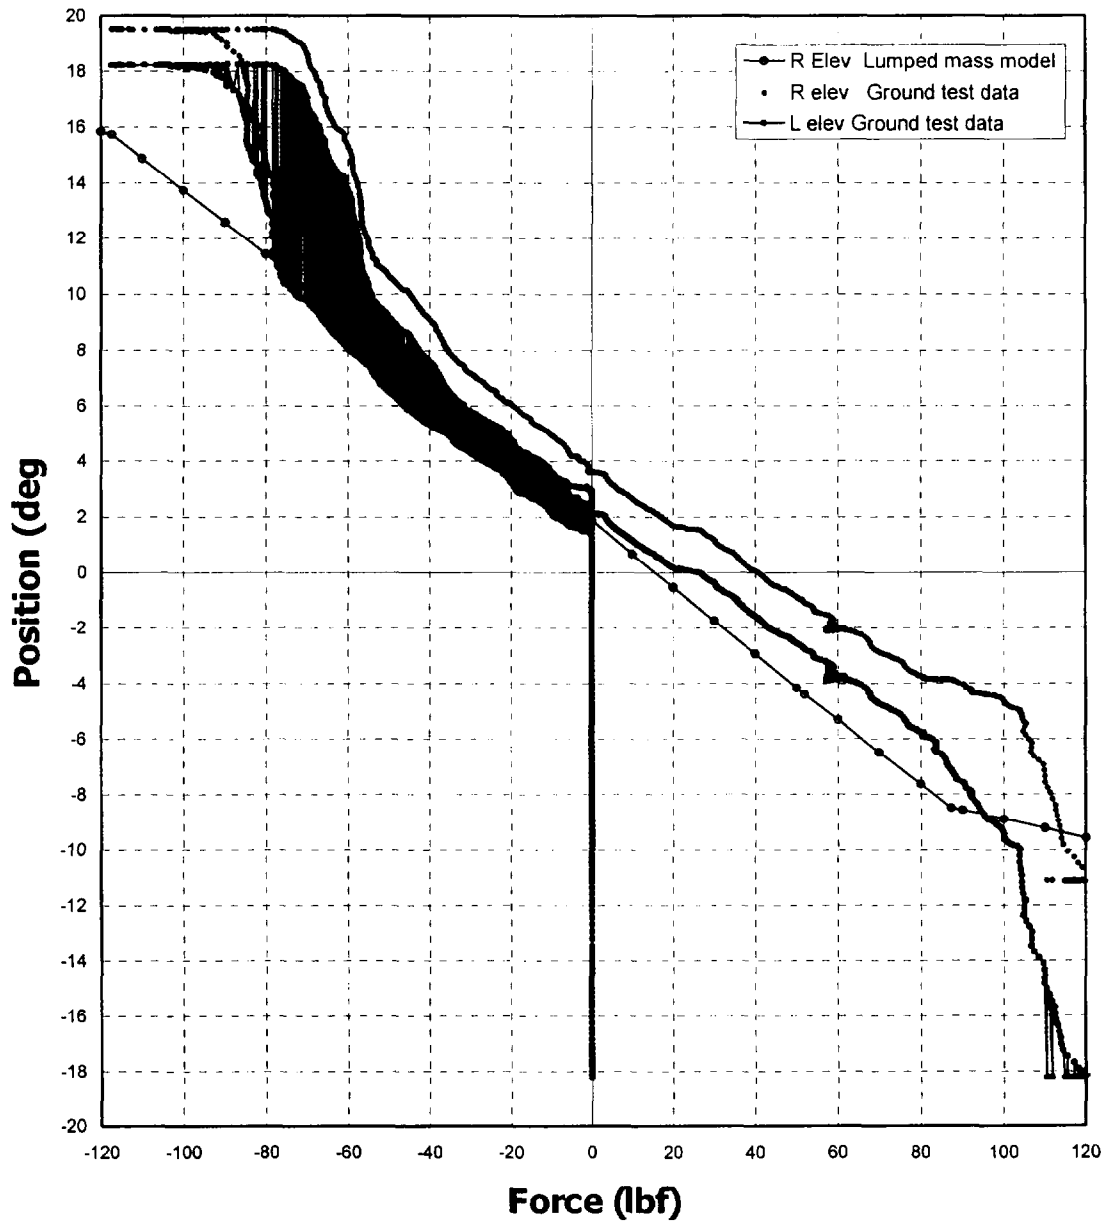
Figures 4, 5, and 6, which are extracted from the ground test data, indicate the elevator movement at a no-load condition as a result of a single PCA valve jam in the TED direction.<sup>2</sup> These figures show the results of three separate tests under the same test conditions –single PCA jam, 770 psi feel pressure, and pilot column sweep. They indicate that the right elevator is always leading the left elevator and are not consistent with the mathematical model included in Boeing report B-H200-17068-ASI-R2 -Split Elevator Failure Scenario, dated September 29, 2000 and Boeing report B-H200-17026-ASI, -767 Elevator System Operation with Regard to Column Splits, Aft Quadrant Splits, and Column Jams, dated August 2, 2000.

Figure 4. Elevator Deflection from Ground Test A and Analytical Model  
Single PCA Control Valve Jam on the Right Elevator, 770 psi Feel Pressure, Pilot  
Control Sweep

Figure 5. Elevator Deflection from Ground Test B and Analytical Model  
Single PCA Control Valve Jam on the Right Elevator, 770 psi Feel Pressure, Pilot  
Control Sweep

Figure 6. Elevator Deflection from Ground Test C and Analytical Model  
Single PCA Control Valve Jam on the Right Elevator, 770 psi Feel Pressure, Pilot  
Control Sweep

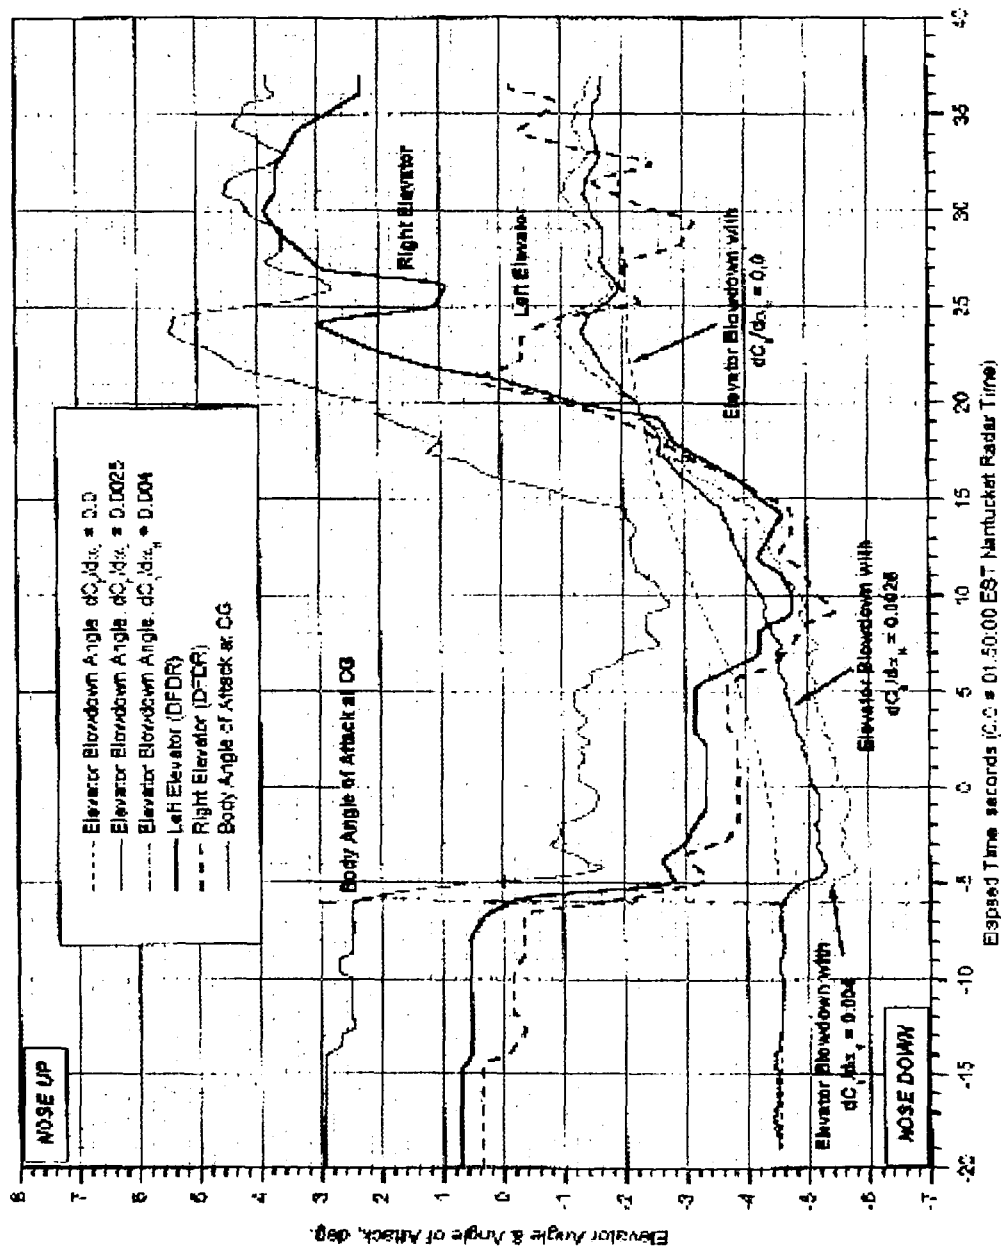
Figure 7. Expected Elevator Deflection as a Result of Dual PCA Valve Jam Failure  
(Produced by the NTSB Performance Group Chairman)

Figure 7 shows the expected elevator deflection as a result of a dual PCA control valve jam using the Boeing hinge moment data with and without considering the effect of airplane body angle variation and the FDR elevator data. These expected deflections were derived by the NTSB performance group chairman and validated by the Egyptian Delegation. From elapsed time of 7 seconds, the calculated right elevator position is within 1 degree of the FDR.<sup>3</sup>

<sup>3</sup> Figure 7 is from the NTSB and does not account for any differences caused by the rate at which the failure occurred. In addition, the labels for right and left elevator are reversed.

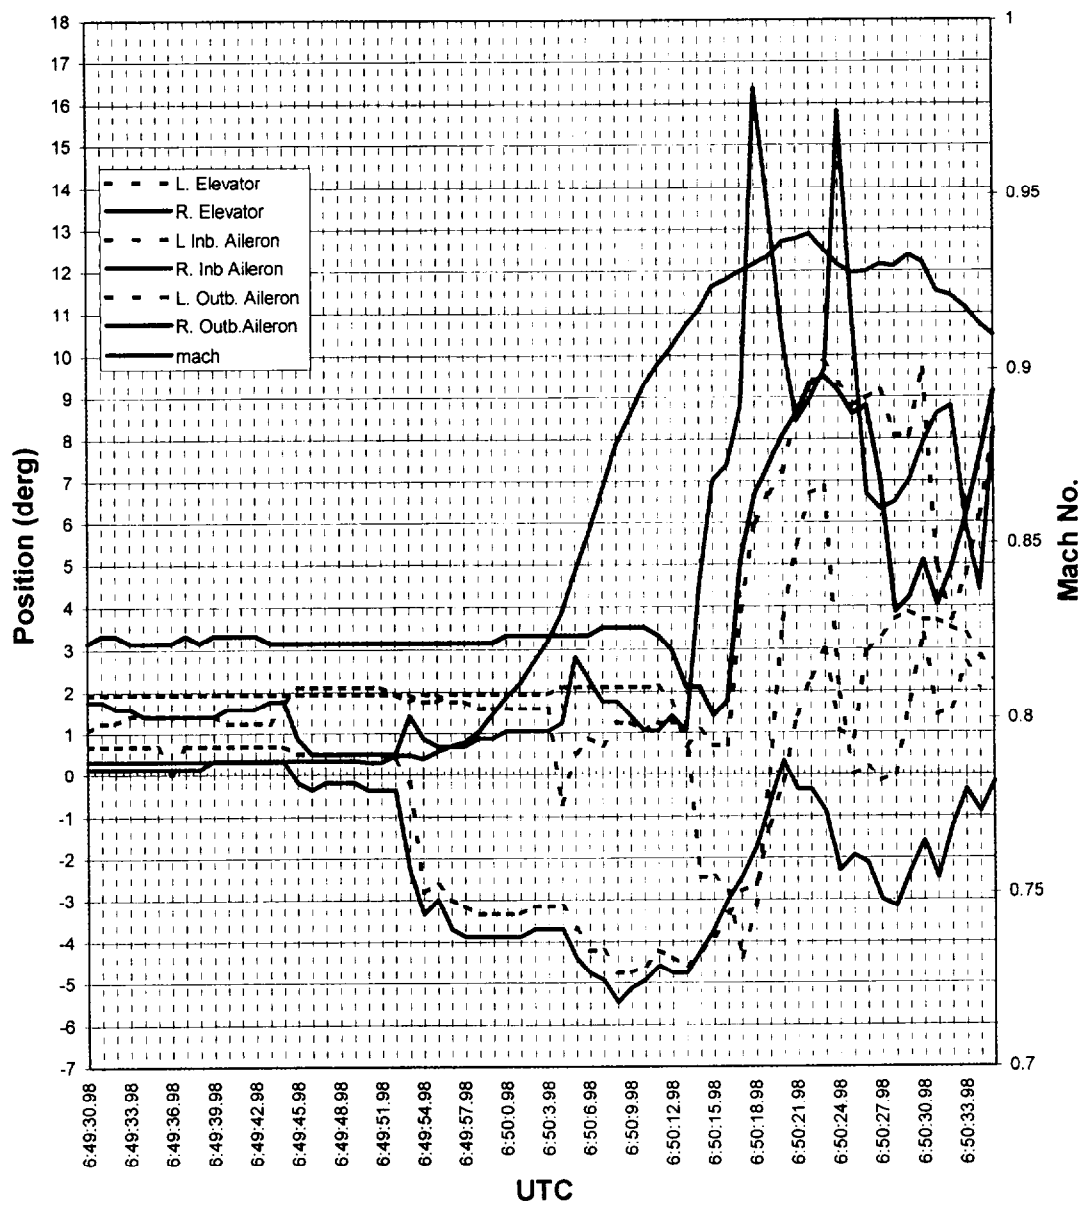
Figure 8. FDR Elevator and Aileron Deflection and Derive Mach Number

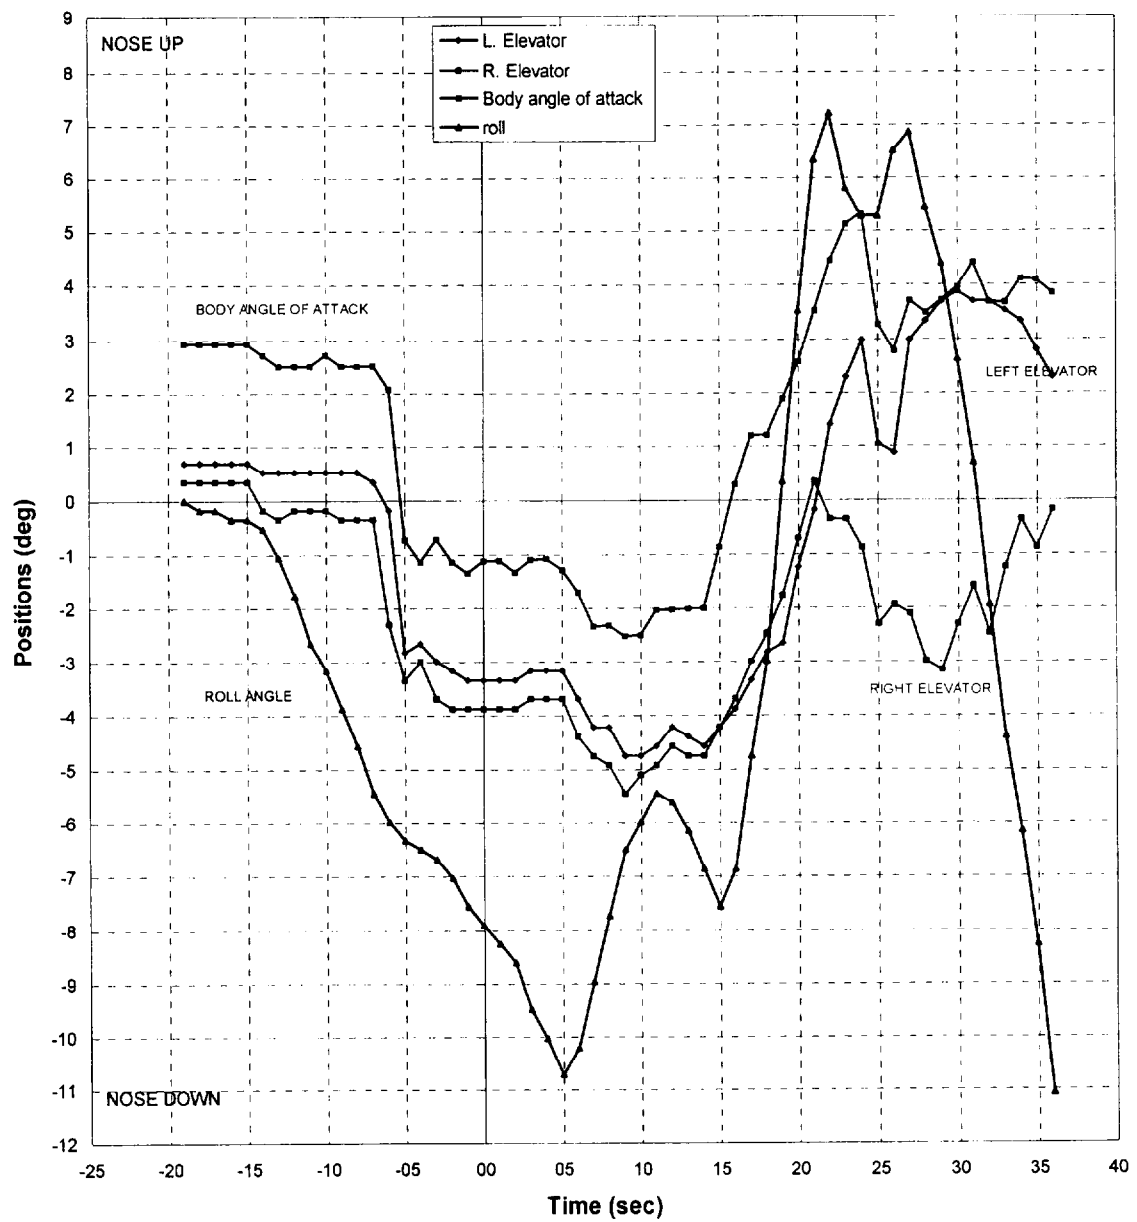
Figure 9. FDR Roll Angle and Derived Body Angle of Attack

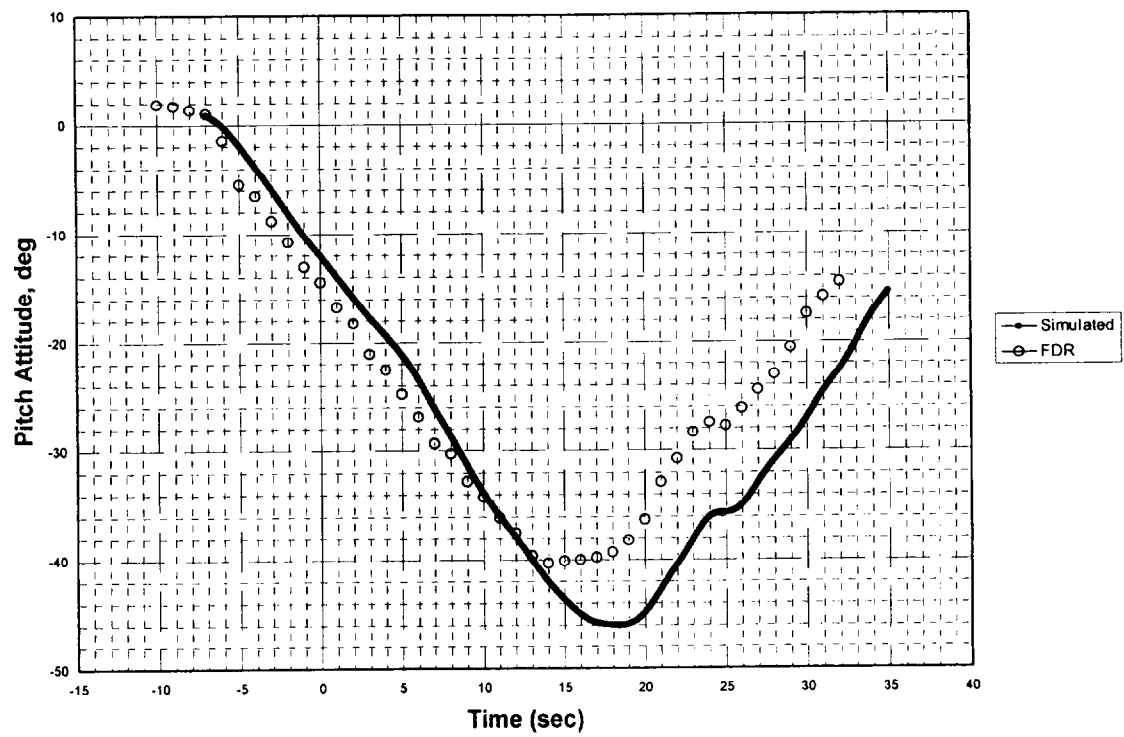
Figure 10. Pitchover Simulation, Right Elevator as Recorded on the FDR

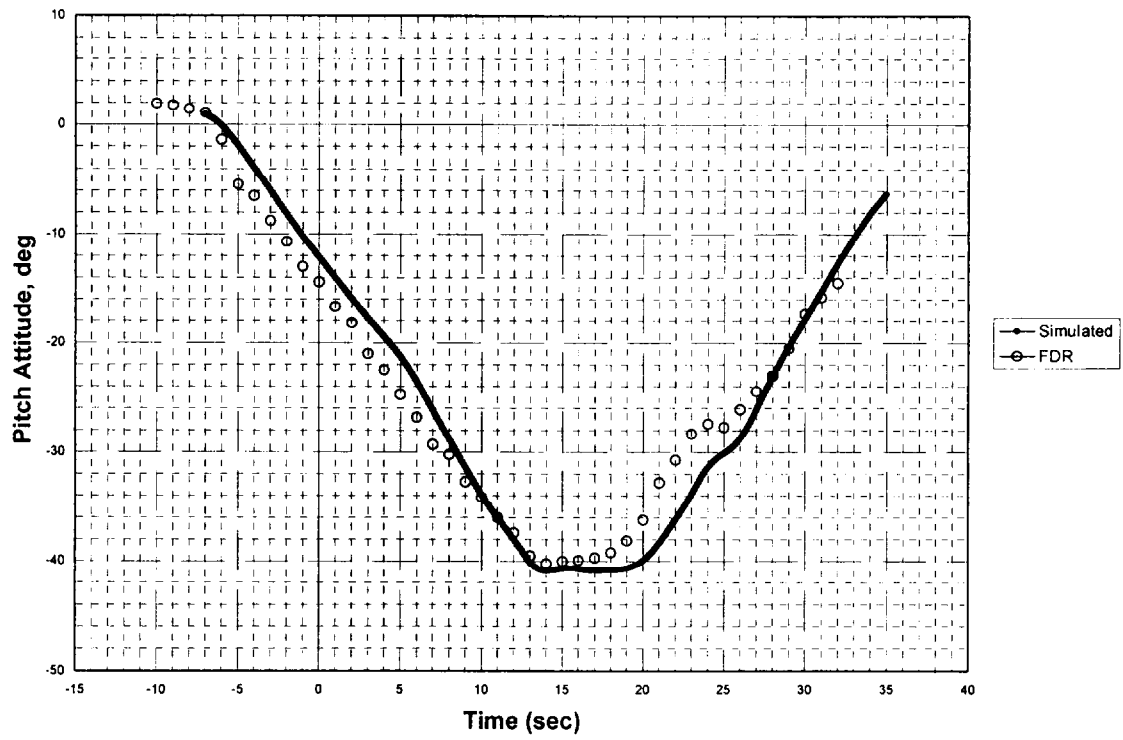
the recorded roll and pitch during the last 15 seconds of data is much closer to the expected aircraft performance if the right elevator is missing.

Figure 11. Pitchover Simulation, Right Elevator Missing

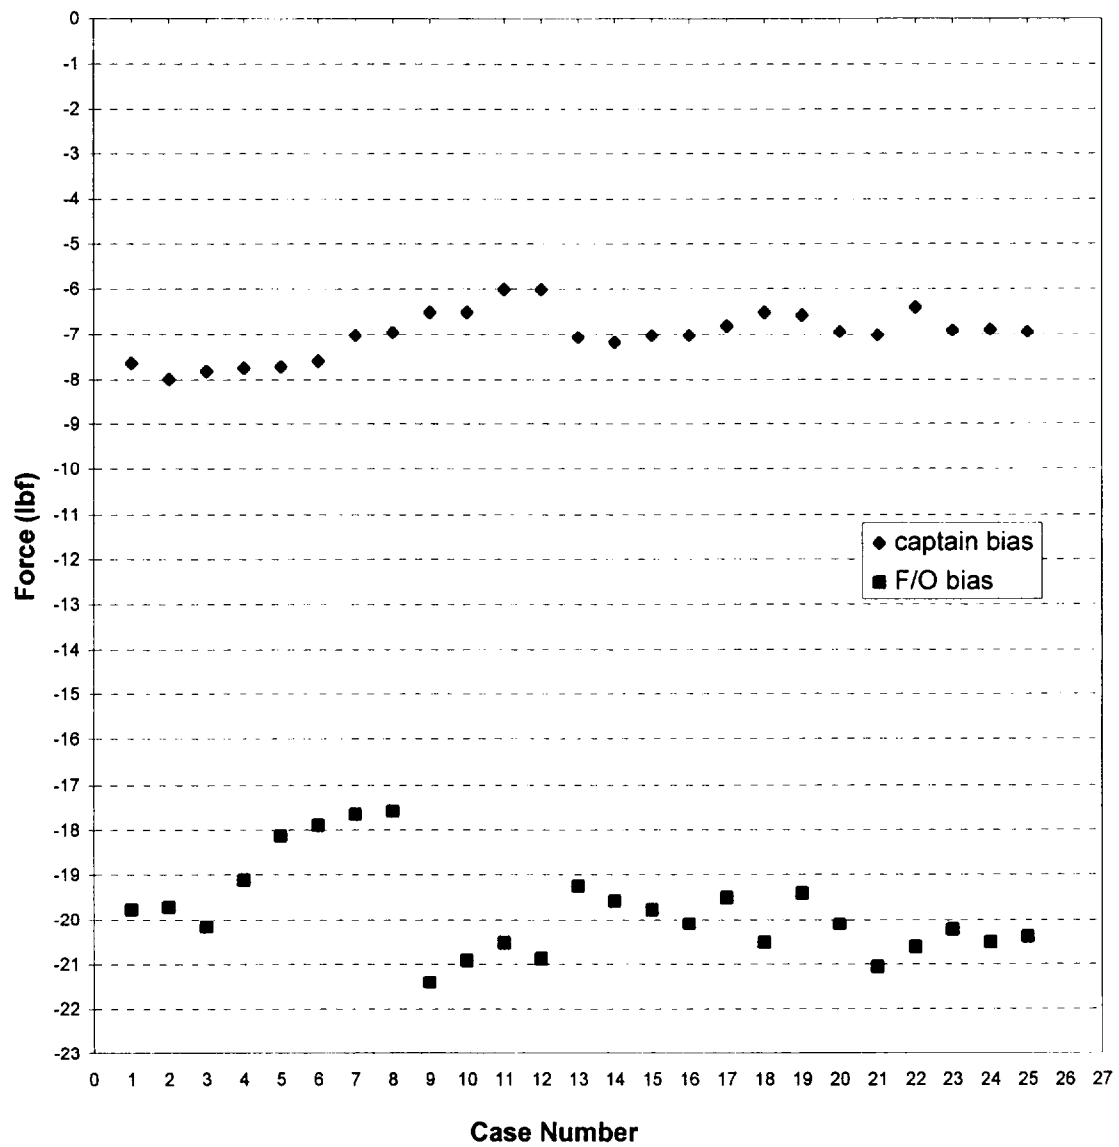
Figure 24. March Ground Test Data, Bias Changes for Captain and First Officer Column Force Measurements

Further, Boeing's explanation of force bias due to temperature effects is not supported by the data. Figure 24 shows the bias on the Captain's column force measurement increasing with time, with the suggestion that changes in temperature caused this change in bias. If temperature were the cause of the change in bias, the bias in the First Officer's force measurement would have increased as well, but it decreased. In addition, the bias on the First Officer's force measurement does not change in the nearly linear manner that the bias on the Captain's force measurement does. If both force transducers have the same specifications, they should react to temperature in a very similar manner; there should not be an opposite reaction to changes in temperature.
